QA-129
Callahan Farm
Queenstown vicinity
Private

RE: Site visit to Philip Callahan Farm (QA-129)

INVENTORY FORM FOR STATE HISTORIC SITES SURVEY

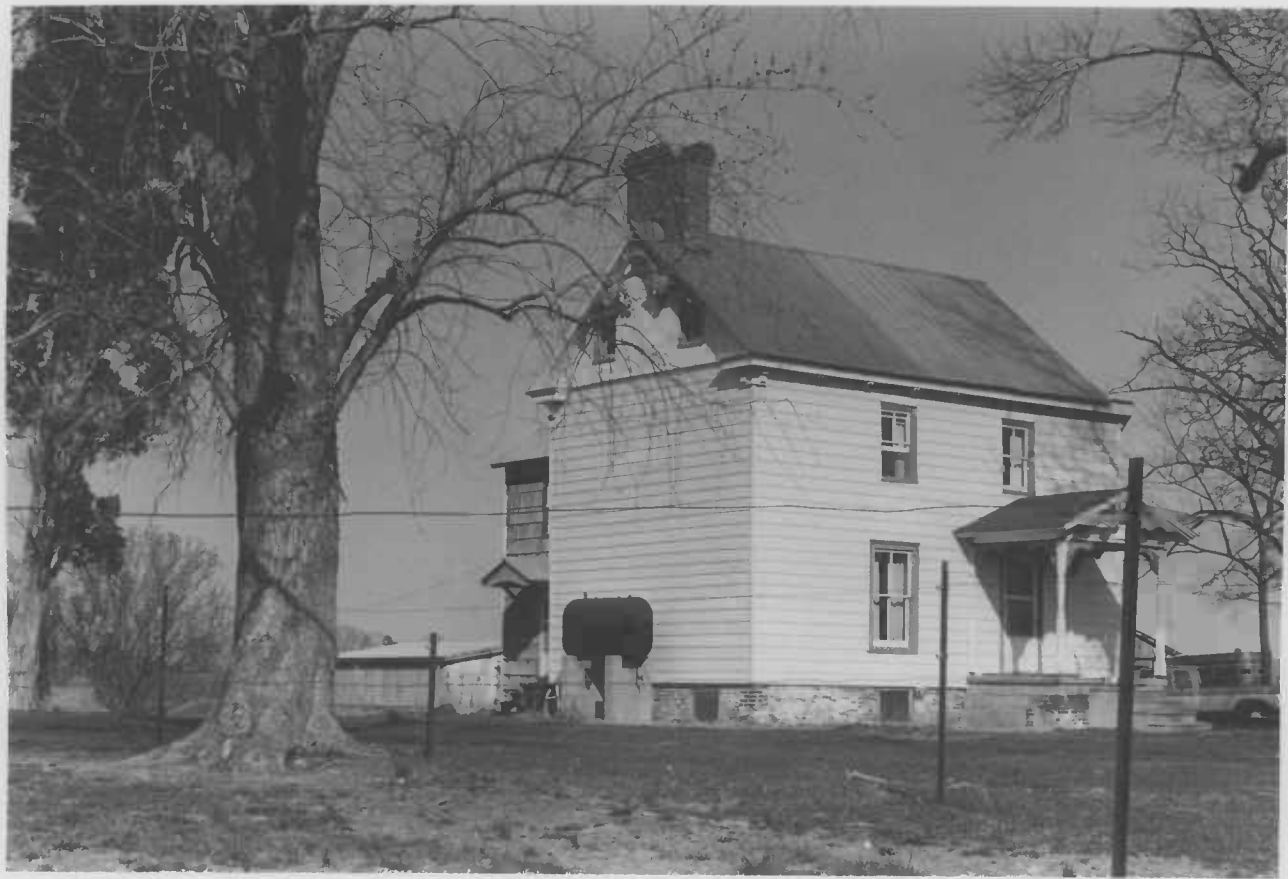
QA-129

The principal facade faces approximately south. There is a door in the east bay and a large 2/2 window in the west bay on the first story and two smaller 2/2 windows similarly placed on the second story. One cellar window is visible in the west bay; there are no dormer windows on the standing seam metal roof. The house rests on a brick foundation and is covered with aluminum siding. The eaves are boxed in and supported with scrolled brackets. A handsome Victorian gable roof porch at the east end of this

House from Southwest

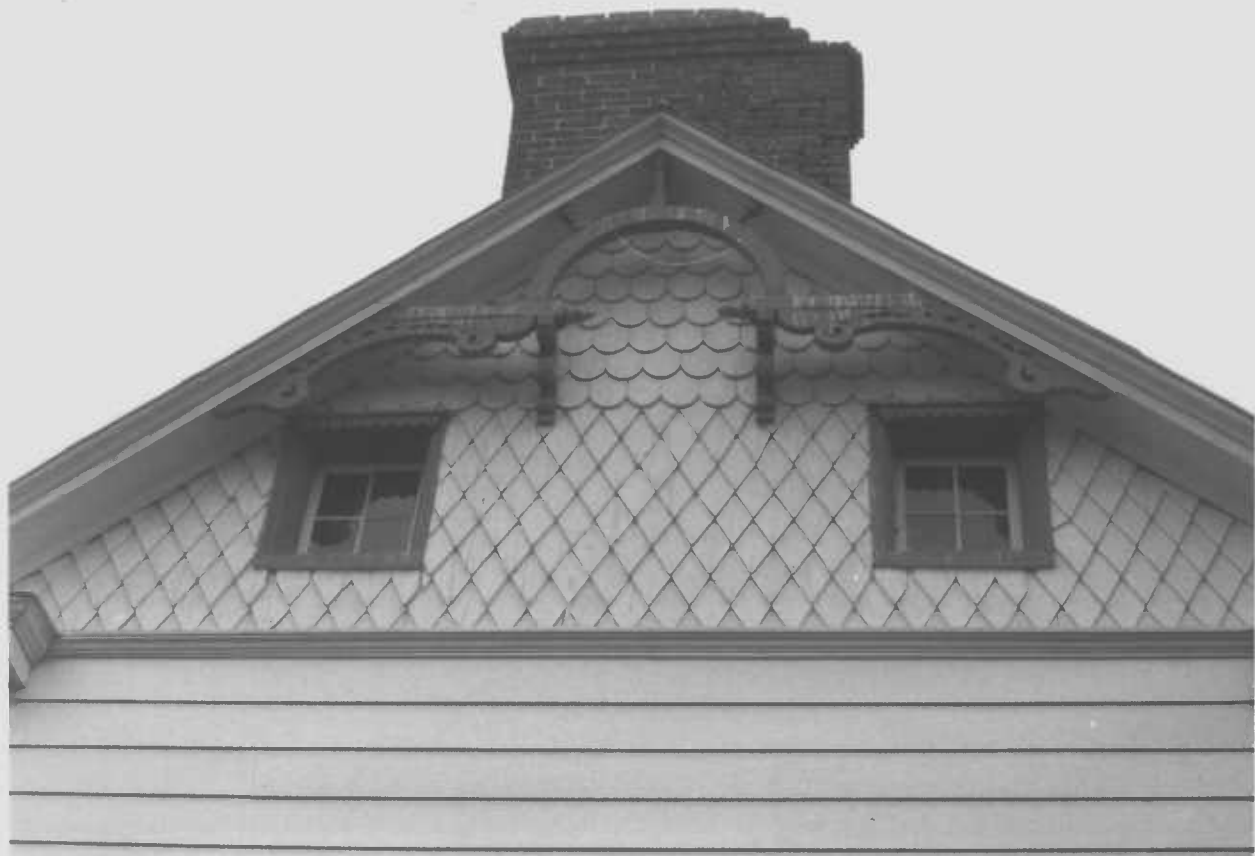
QA-129

The only openings in the west gable are a pair of cellar windows and two four-light windows flanking the chimney in the upper gable. The Victorian period cornice remains intact in the upper gable, with decorative wood shingle siding and elaborately scroll-sawn decorative work in the gable peak. The large corbeled chimney remains largely intact and is a clear indication that the house predates the Victorian period.

A pair of small windows in the upper gable are the only openings in the west gable facade. The aluminum siding is carried up to the top of the second story cornice, which returns at the corners. Decorative wood shingle siding survives above this point. The gable eaves are boxed and trimmed with a complex crown mold and decorative scrollwork verge boards enhance this portion of the house.

Callahan Farm
Queenstown vicinity
Rita Suffness, April 1979
Detail of west gable
